OHIO RIVER BASIN
McCUNE RUN, WESTMORELAND COUNTY
PENNSYLVANIA

NDI No. Pa. - 480
KEYSTONE DAM

PHASE I INSPECTION REPORT
NATIONAL DAM INSPECTION PROGRAM

GAI CONSULTANTS, INC.
570 BEATTY ROAD
MONROEVILLE, PENNSYLVANIA 15146

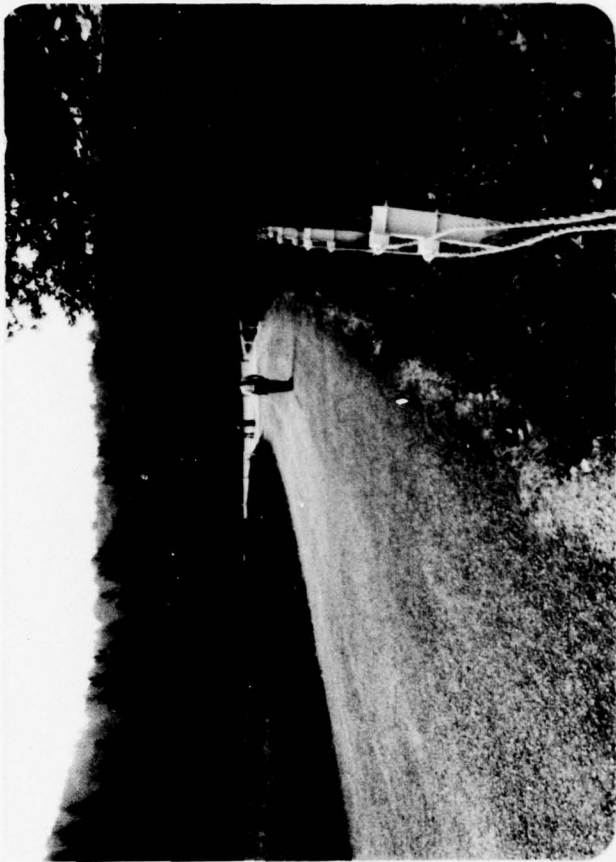
PHOTOGRAPH 12

1. Spillway. The spillway serving Keystone Dam is a channel cut in rock on the left abutment (see Photographs 3 and 9, Appendix D). The spillway discharges into an artificial drainage channel that joins the natural channel approximately 600 feet downstream of the dam. The spillway channel from the sill to the stilling basin is in good condition, however, the channel below the stilling basin exhibits severe and undesirable erosion (see Photographs 3, 11 and 12 of Appendix D).

View looking east (upstream) toward the spillway. Water in the background enters a masonry stilling basin. Note the color change in the stream channel from clear at the stilling basin to bright orange in the foreground. Acid mine drainage presumably enters the stream through fractures in the bedrock.

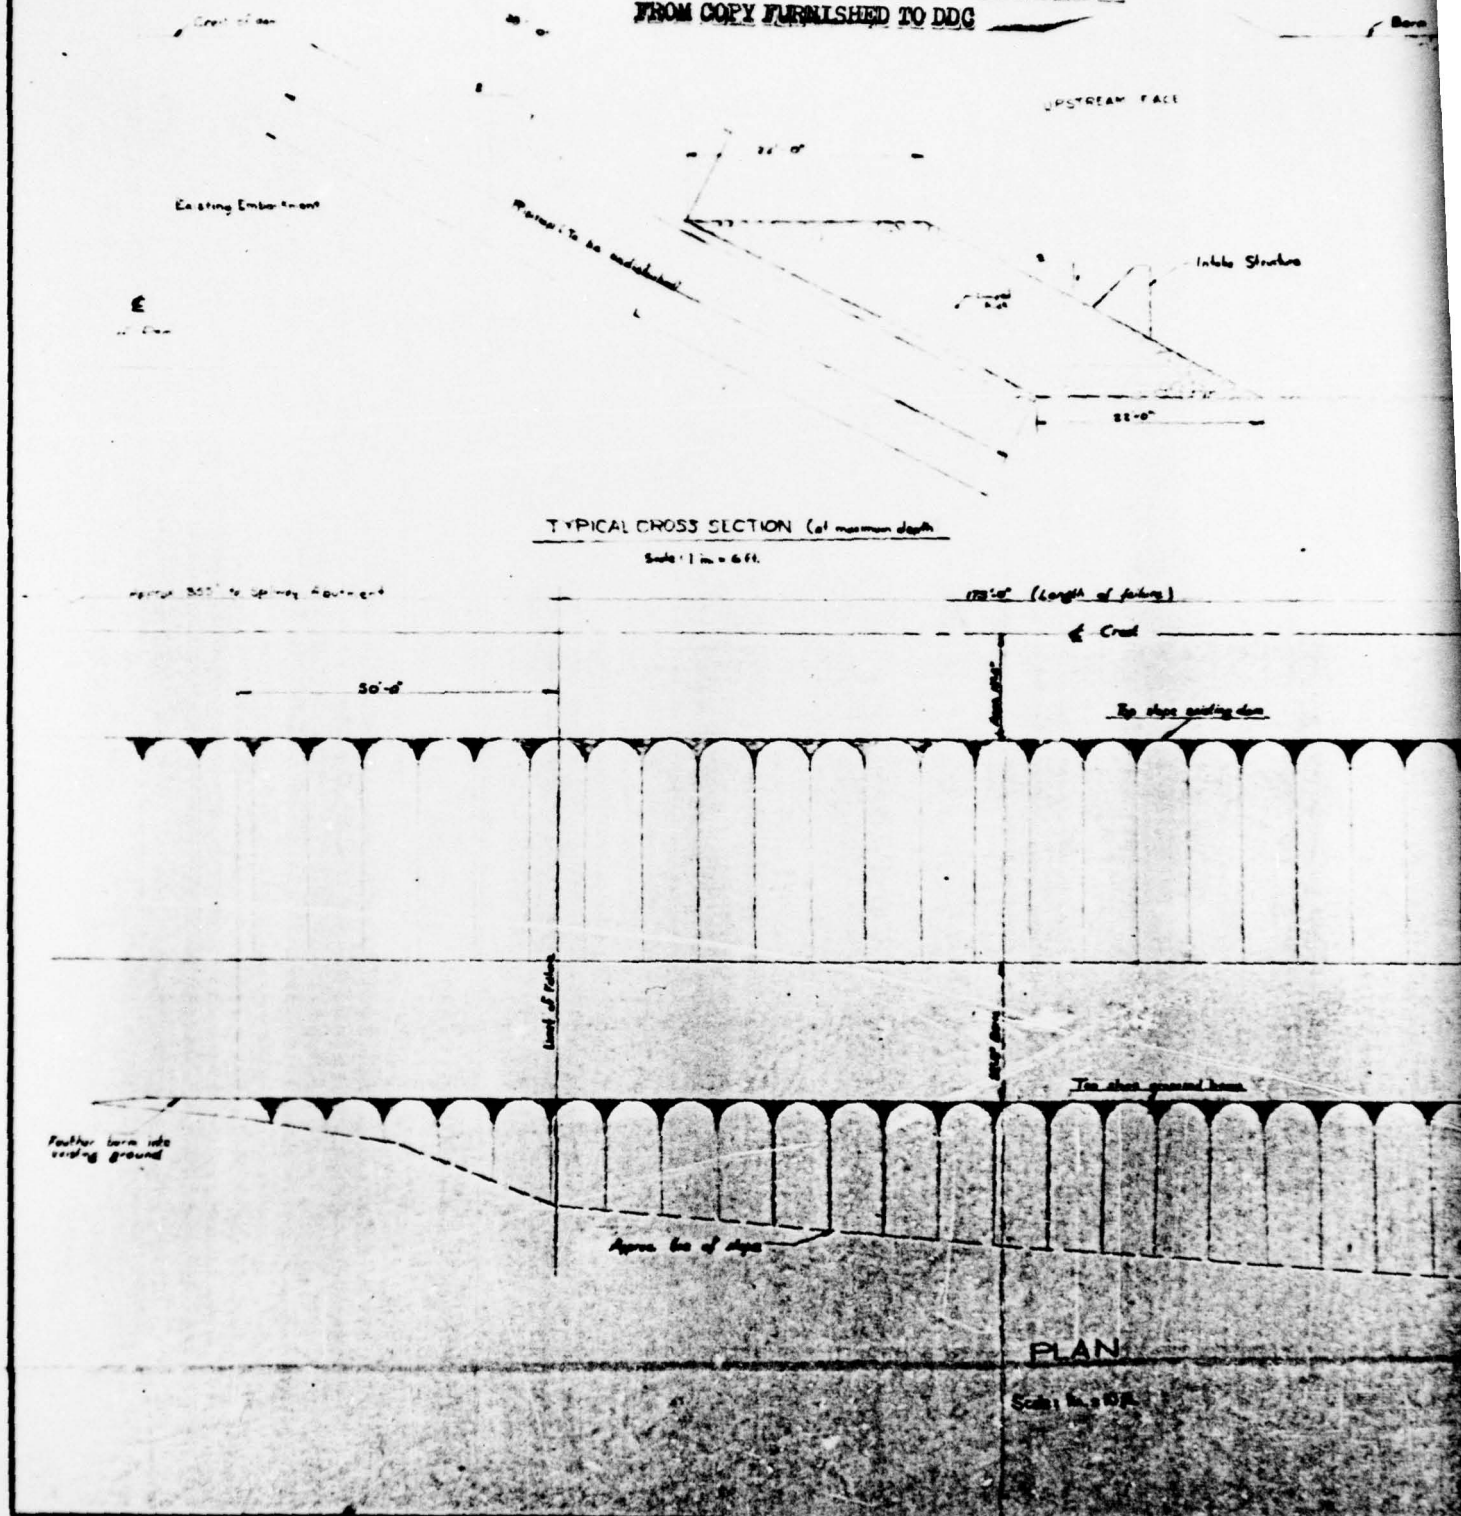
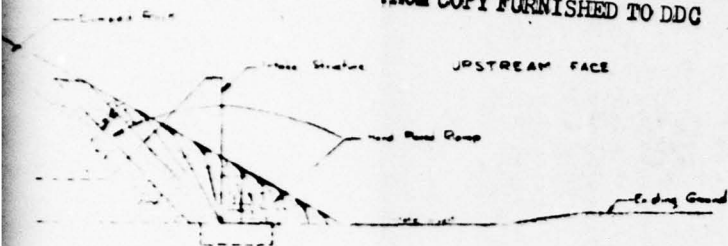
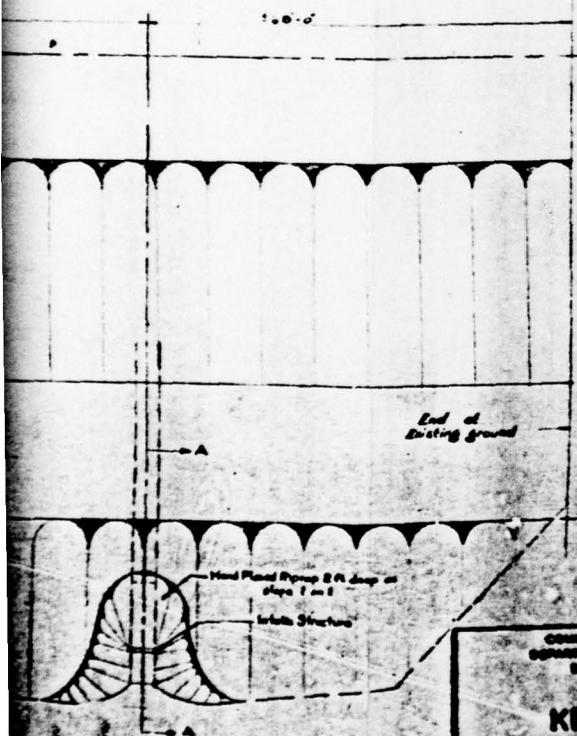
FIGURE 5

A major modification of the embankment was made in 1957. A trapezoidal-shaped berm of riprap material was placed along the length of the upstream toe. The general configuration is shown in Figure 5.
